# Inspection Report

## Mold Sample

**Property Address:**  
12345 Mold Sample Report  
Edmond OK

### Mighty Fortress Inspections

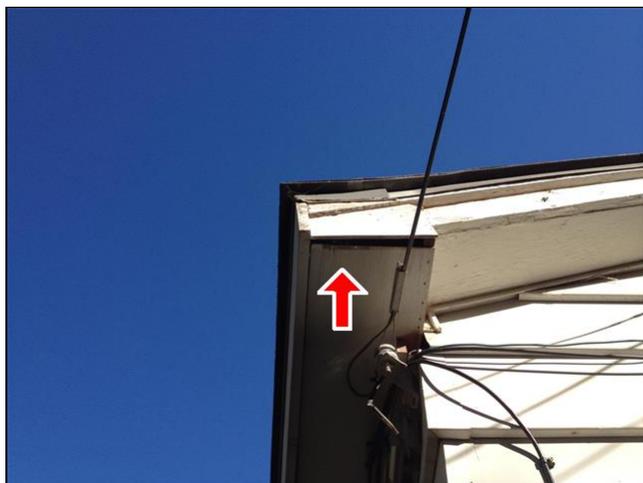
1.1 Item 1(Picture)

There is a gap in the soffit that can allow water penetration.

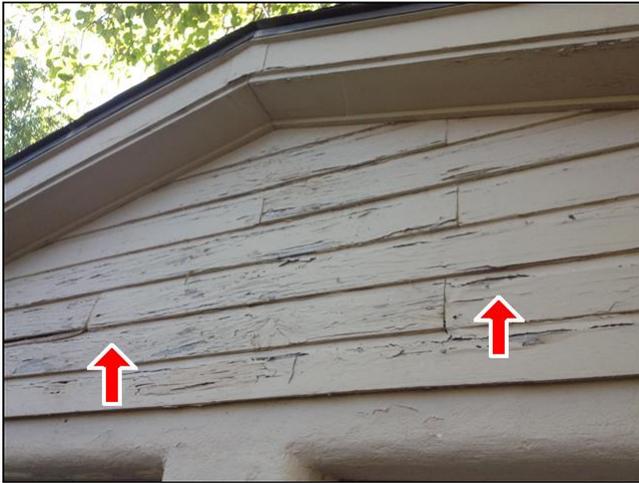
1.2 Item 1(Picture)

The siding is failing and needs to be painted to prevent water penetration.

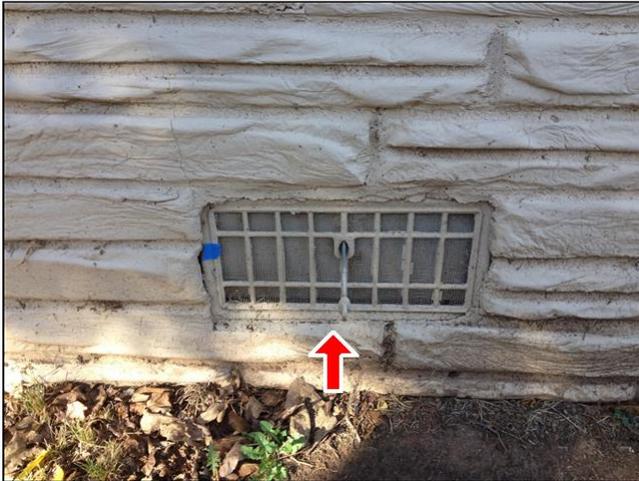
1.3 Item 1(Picture)

Crawl spaces need to be vented year round to prevent moisture build up.

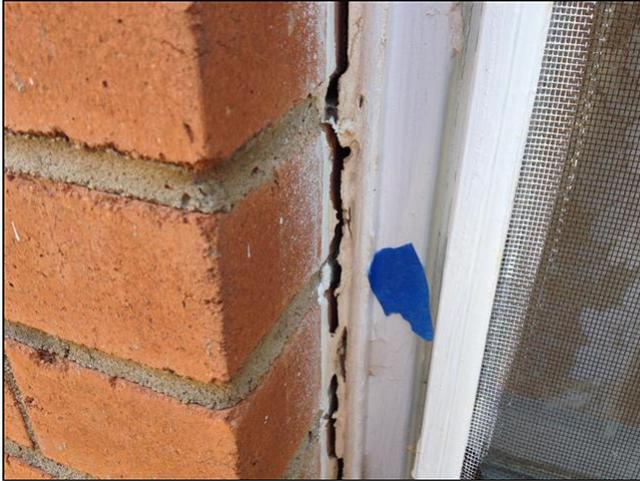
1.5 Item 1(Picture)

Windows need to be sealed to prevent water penetration.

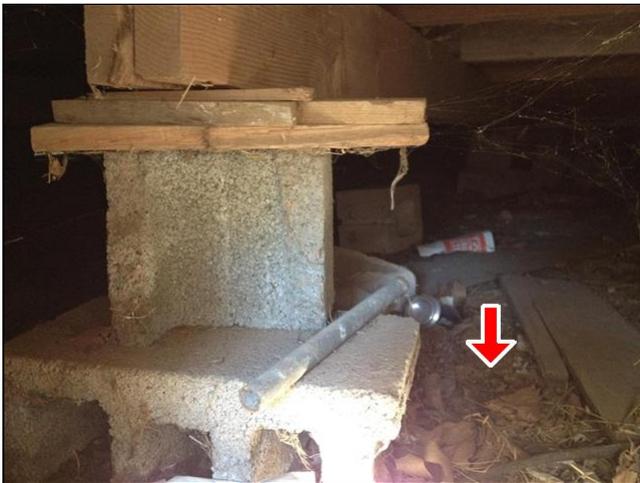
1.7 Item 1(Picture)

The crawl space floor needs a vapor barrier installed on the bare earth. This can allow more moisture build up in the crawlspace.

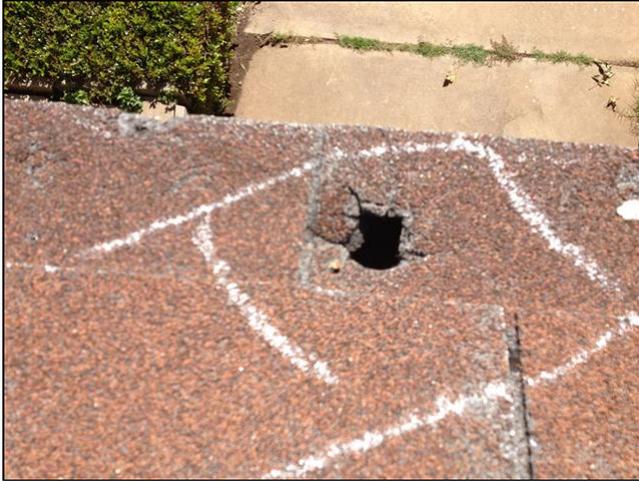
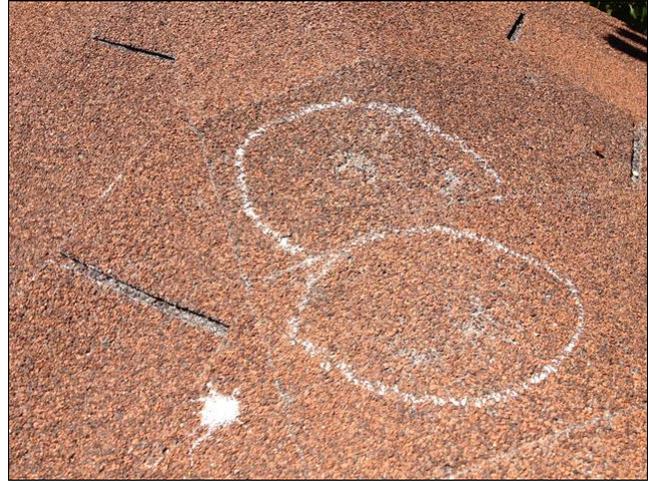
1.8 Item 1(Picture)

There is a hole in the roof which could allow water into the home.

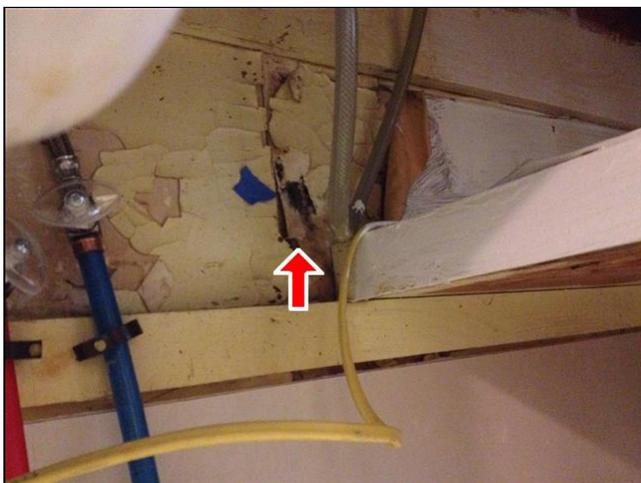
2.2 Item 1(Picture)

A mold like substance was discovered on the sink base bottom at the Kitchen. A sample was collected for convenience, but will not be sent to the laboratory unless authorized and pre-paid by the customer. Refer to the report summary for instructions. The lab code for this sample is the item number.

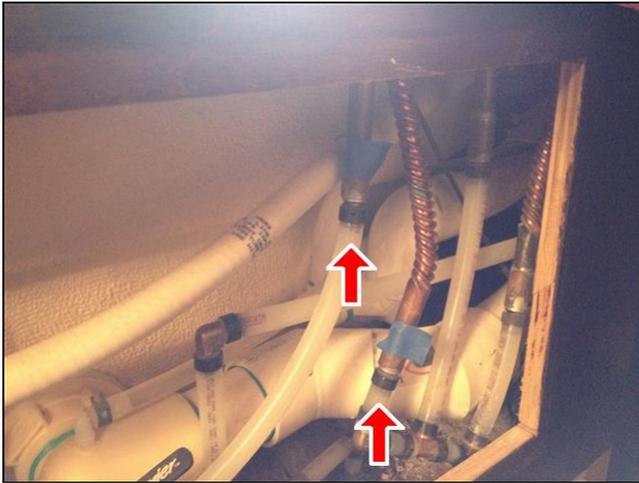
2.5 Item 1(Picture)

There is a leak on the master bath tub that needs to be fixed. This could lead to mold growth in the future.

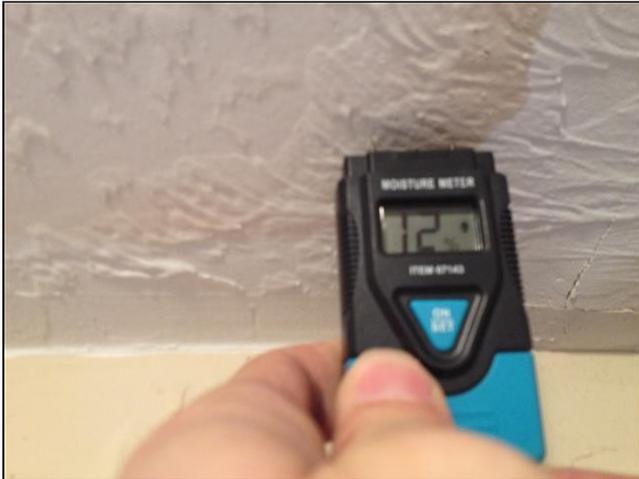
2.6 Item 1(Picture)

There is signs of water damage inside the closet. It does not appear active at this time.

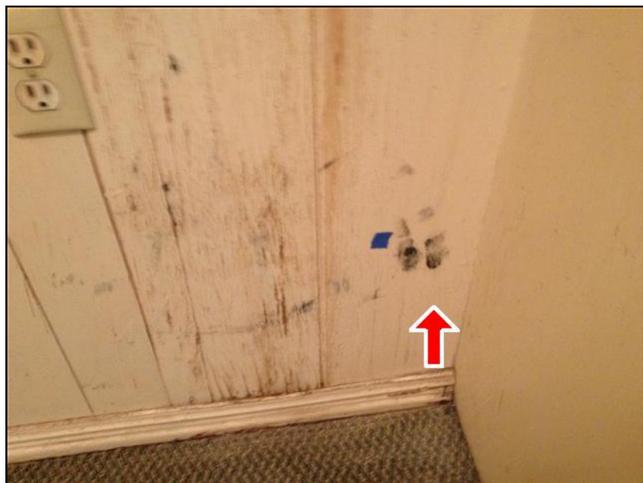
2.7 Item 1(Picture)

A mold like substance was discovered on the wall the walls behind washer/dryer at the Washer/Dryer room. A sample was collected for convenience, but will not be sent to the laboratory unless authorized and pre-paid by the customer. Refer to the report summary for instructions. The lab code for this sample is the item number.

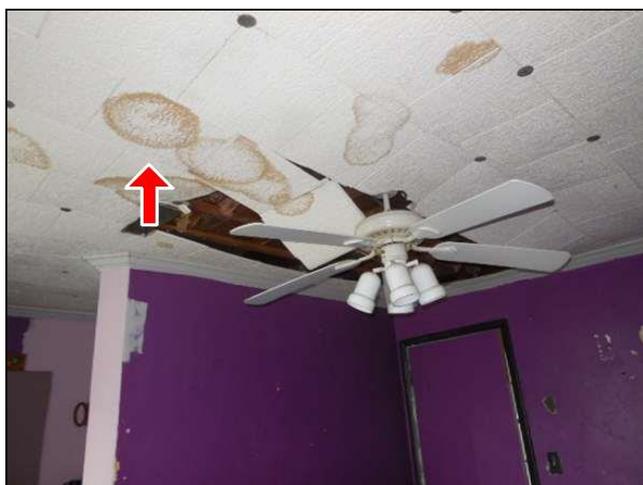
2.9 Item 1(Picture)

A mold like substance was discovered on ceiling at the Bedroom. A sample was collected for convenience, but will not be sent to the laboratory unless authorized and pre-paid by the customer. Refer to the report summary for instructions. The lab code for this sample is the item number.

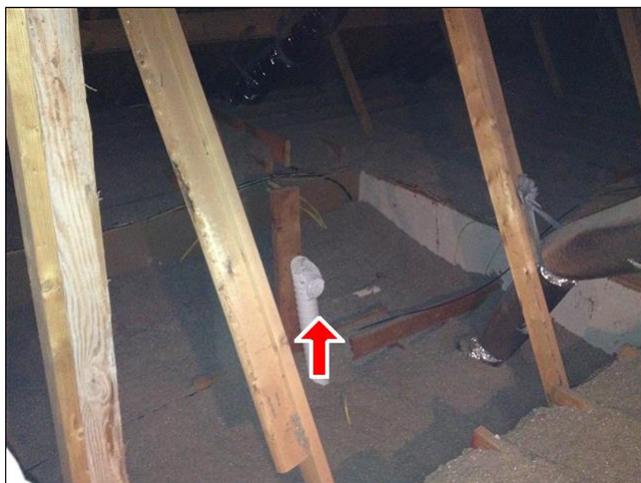
2.13 Item 1(Picture)

The bath vent does not vent to the exterior. This can cause excess moisture to be released into the attic.
